**Flood Control Project Maintenance  
Levee Inspections**

## Maintenance Issue Types Only, Levee Inspection Report By Mile - Fall 2015

### Reclamation District No. 2031 Elliot

Waterway	Bank	Unit Miles	Inspection Start/End	Inspector
Unit No. 01 Stanislaus River	Left	7.07	10/07/2015 10/07/2015	Maksim Khashchuk

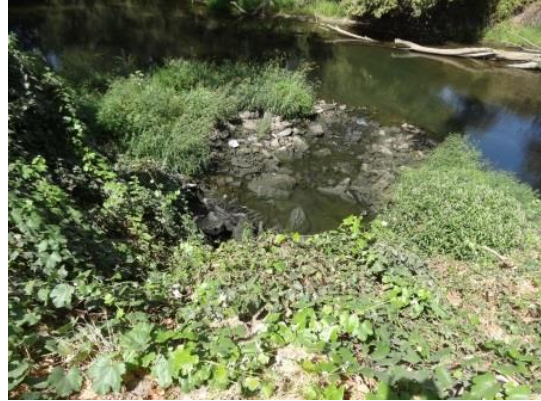
Photo 1 of 3 : SJR2015\_RD2031U01RM0.48\_3.jpg

Inspector Comments: 08/28/2015: No significant change observed.  
 07/31/2014: No significant change observed.  
 09/10/2013: No significant change observed.  
 07/18/2012: No significant change observed.  
 08/18/2011: No significant change observed on site. Debris that blocks the irrigation outlet is visible.  
 10/19/2010: No significant change observed on site. Sloughing of the bank is occurring adjacent to an irrigation outlet structure. There is moderate to heavy vegetation along the bank that is well established. Broken chunks and slabs of concrete are used as rip rap and line the outside of the irrigation outlet structure. However, much of the rip rap along the slope is sloughing and could possibly lead to future slope instability.  
 08/05/2010: Recommended as a local maintenance issue, per CLRO.  
 08/20/2009: No major change observed since last visit; 1 inch fissure cracks developing on the slope; rip rap is showing signs of sloughing; recommend as local maintenance issue; site was previously rated "U".

2008: No change from previous year; irrigation outlet located on site; rip rap placed on river bank.  
 09/06/2007: Near agricultural diversion; only 3' landside height differential. [2015 Site ID:RD2031U01RM0.48]

Looking down at the site.

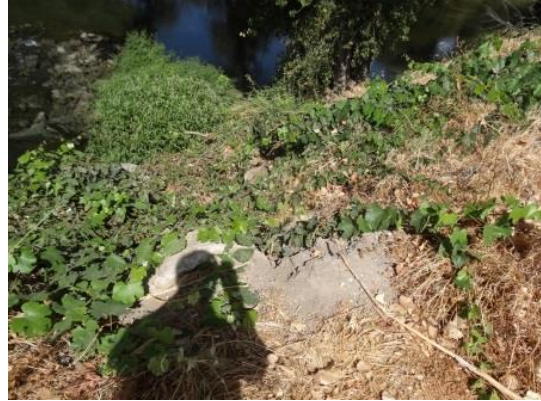
Photo 2 of 3 : SJR2015\_RD2031U01RM0.48\_4.jpg

View of the current condition of the bank slope just above the irrigation outlet.

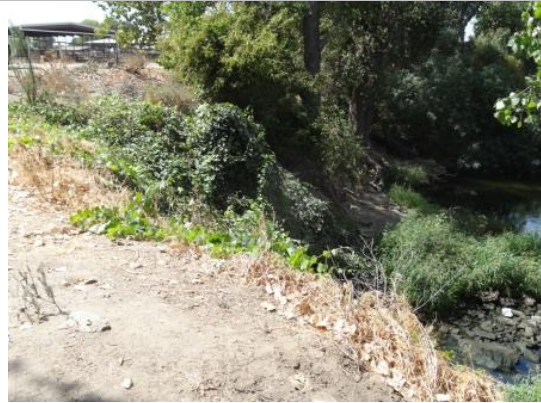
Photo 3 of 3 : SJR2015\_RD2031U01RM0.48\_6.jpg

View of the loose material at the bank top.

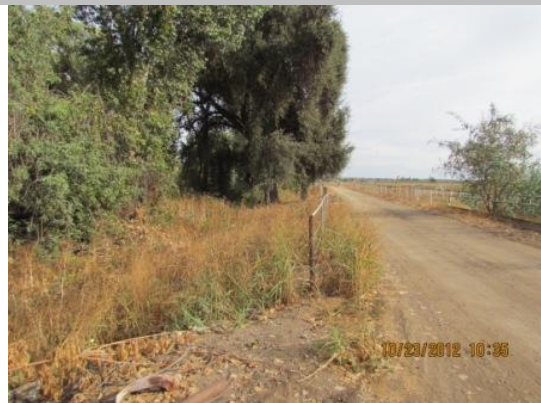
Photo 1 of 2 : FA\_2015\_RD2031\_307\_2\_20150910\_00002.jpg

LM Start	<b>0.48</b>	Rating **	M	Issue No.	<b>2</b>
LM End	<b>0.51</b>	Issue Type +	Ma	Location *	WS
Category	Earthen Levee		GPS Latitude/Longitude		
			Start	End	
Item	Vegetation		37.704385 °	37.704050 °	
			-121.159217 °	-121.159578 °	
DWR ID	DWR_RD2031_01_s_2012_2

View of vegetation on waterside slope. Facing upstream.

Remove the wild growth other than native grasses from the levee slopes.  
 Inspector Comments: Remove vegetation 20 feet away from the levee crown.

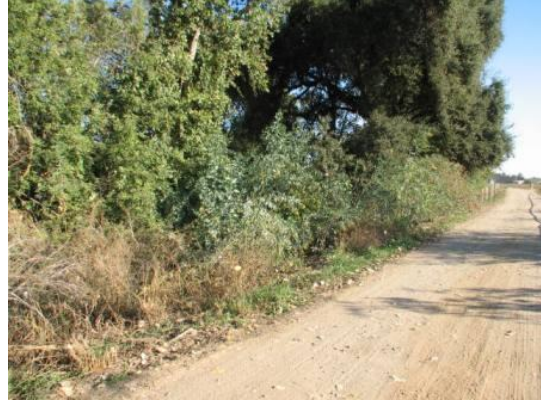
Photo 2 of 2 : FA\_2015\_RD2031\_307\_2\_20150910\_00003.jpg

10/26/2011 Updated photo of waterside vegetation.

LM Start	0.48	Rating **	M	Issue No.	2 (cont)
LM End	0.51	Issue Type +	Ma	Location *	WS
Category	Earthen Levee			GPS Latitude/Longitude	
				Start	End
Item	Vegetation			37.704385 °	37.704050 °
				-121.159217 °	-121.159578 °
DWR ID	DWR_RD2031_01_s_2012_2				
Action/Comments					
Remove the wild growth other than native grasses from the levee slopes. Inspector Comments: Remove vegetation 20 feet away from the levee crown.

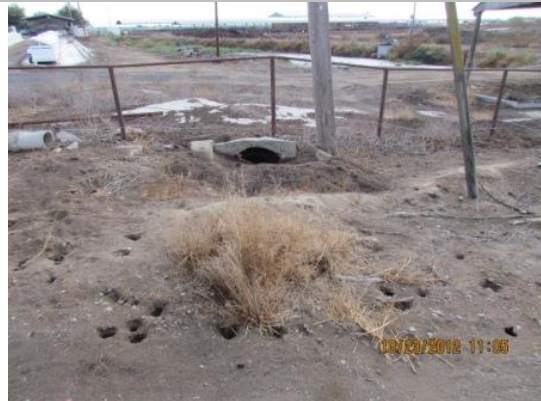
Photo 1 of 1 : FA\_2015\_RD2031\_307\_36\_20150910\_00019.jpg

LM Start	0.77	Rating **	M	Issue No.	36
LM End	0.77	Issue Type +	Ma	Location *	LS
Category	Earthen Levee			GPS Latitude/Longitude	
				Start	End
Item	Animal Control			37.701177 °	37.701177 °
				-121.162055 °	-121.162055 °
DWR ID	DWR_RD2031_01_f_2012_36				
Action/Comments					
No rodents visible, but rodent burrows visible; need to backfill and compact or grout burrows.

View of rodent burrows on landside slope.

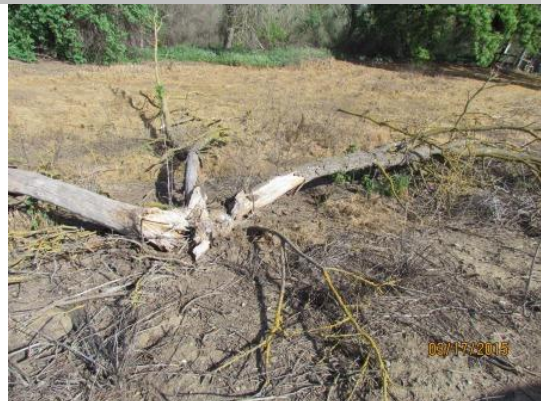
Photo 1 of 1 : FA\_2015\_RD2031\_307\_49\_20150910\_00026.jpg

LM Start	0.91	Rating **	N	Issue No.	49
LM End	0.91	Issue Type +	Ma	Location *	WS
Category	Earthen Levee			GPS Latitude/Longitude	
				Start	End
Item	Trim / Thin Trees			37.699790 °	37.699790 °
				-121.163730 °	-121.163730 °
DWR ID	DWR_RD2031_01_s_2015_49				
Action/Comments					
Tree stumps.

View of the tree stump on the waterside levee slope.

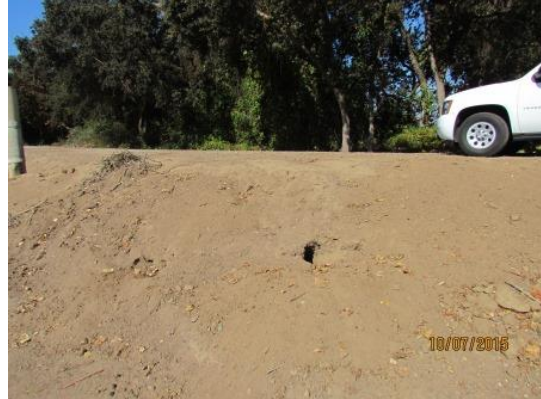
Photo 1 of 1 : FA\_2015\_RD2031\_307\_59\_20151008\_00053.jpg

LM Start	1.00	Rating **	M	Issue No.	59
LM End	1.00	Issue Type +	Ma	Location *	LS
Category	Earthen Levee			GPS Latitude/Longitude	
				Start	End
Item	Animal Control			37.699327 °	37.699327 °
				-121.165364 °	-121.165364 °
DWR ID	DWR_RD2031_01_f_2014_59				
Action/Comments					
Exterminate rodents and backfill and compact or grout burrows.

View of the multiple rodent holes on the landside levee slope.

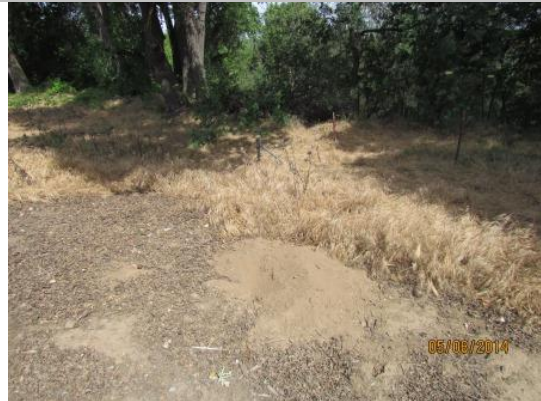
Photo 1 of 1 : FA\_2015\_RD2031\_307\_128\_20150910\_00036.jpg

LM Start	1.14	Rating **	M	Issue No.	128
LM End	1.14	Issue Type +	Ma	Location *	WS
Category	Earthen Levee			GPS Latitude/Longitude	
				Start	End
Item	Animal Control			37.698873 °	37.698873 °
				-121.167785 °	-121.167785 °
DWR ID	DWR_RD2031_01_s_2014_128				
Action/Comments					
Exterminate rodents and backfill and compact or grout burrows.

View of the rodent hole on the waterside levee slope.

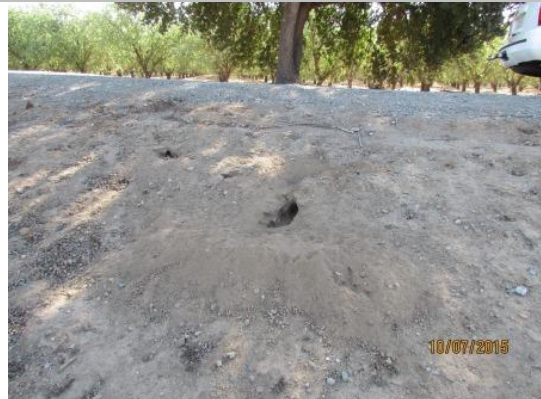
Photo 1 of 1 : FA\_2015\_RD2031\_307\_54\_20151008\_00054.jpg

LM Start	1.49	Rating **	M	Issue No.	54
LM End	1.49	Issue Type +	Ma	Location *	WS
Category	Earthen Levee			GPS Latitude/Longitude	
				Start	End
Item	Animal Control			37.699554 °	37.699554 °
				-121.173417 °	-121.173417 °
DWR ID	DWR_RD2031_01_f_2015_54				
Action/Comments					
Exterminate rodents and backfill and compact or grout burrows.

View of the multiple rodent holes on the waterside levee slope.

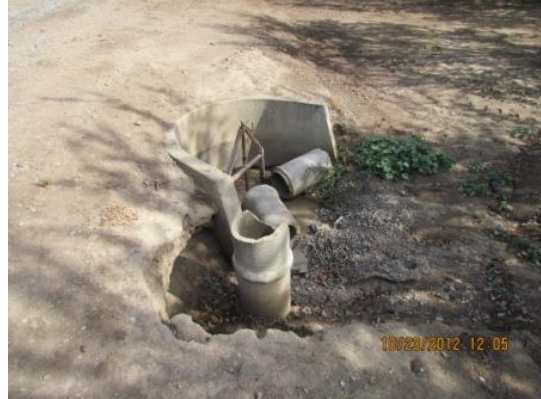
Photo 1 of 2 : FA\_2015\_RD2031\_307\_3\_20150910\_00004.jpg

LM Start	1.56	Rating **	U	Issue No.	3
LM End	1.56	Issue Type +	Ma	Location *	LS
Category	Earthen Levee			GPS Latitude/Longitude	
				Start	End
Item	Erosion / Bank Caving			37.698776 °	37.698776 °
				-121.174327 °	-121.174327 °
DWR ID	DWR_RD2031_01_s _ 2012_3				
Action/Comments					
Note and monitor erosion site.					
Inspector Comments: Erosion is active around the irrigation standpipe.

View of the erosion site on landside slope, facing upstream.

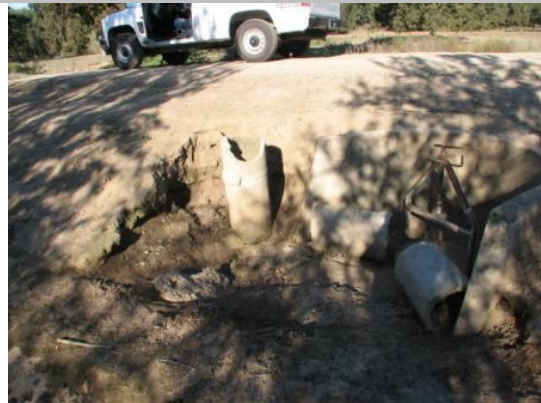
Photo 2 of 2 : FA\_2015\_RD2031\_307\_3\_20150910\_00005.jpg

10/26/2011 Active erosion into the levee prism around irrigation standpipe.

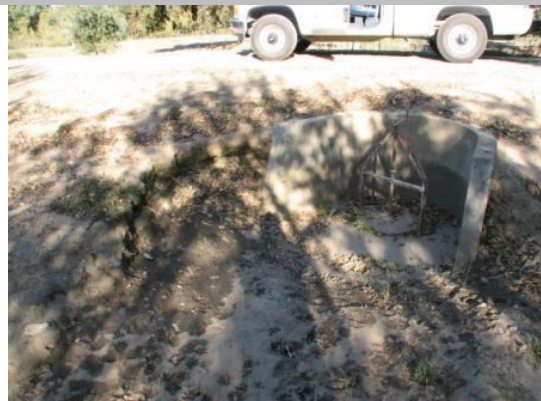
Photo 1 of 1 : FA\_2015\_RD2031\_307\_8\_20150910\_00010.jpg

LM Start	1.58	Rating **	U	Issue No.	8
LM End	1.58	Issue Type +	Ma	Location *	WS
Category	Earthen Levee			GPS Latitude/Longitude	
				Start	End
Item	Erosion / Bank Caving			37.698610 °	37.698610 °
				-121.174598 °	-121.174598 °
DWR ID	DWR_RD2031_01_s _ 2012_8				
Action/Comments					
Note and monitor erosion site.					
Inspector Comments: Active erosion is occurring around irrigation inlet.

10/26/2011 Active erosion shown around irrigation inlet.

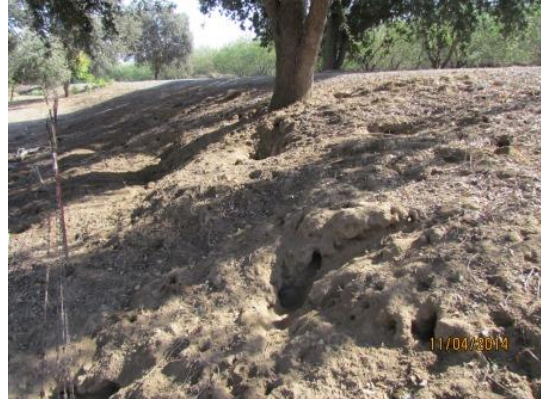
Photo 1 of 2 : FA\_2015\_RD2031\_307\_52\_20150910\_00029.jpg

LM Start	1.62	Rating **	U	Issue No.	52
LM End	1.62	Issue Type +	Ma	Location *	WS
Category	Earthen Levee			GPS Latitude/Longitude	
				Start	End
Item	Animal Control			37.698334 °	37.698334 °
				-121.175176 °	-121.175176 °
DWR ID	DWR_RD2031_01_f_2013_52				
Action/Comments					
No rodents visible, but rodent burrows visible; need to backfill and compact or grout burrows.

View of the multiple large rodent hole in the waterside levee slope.

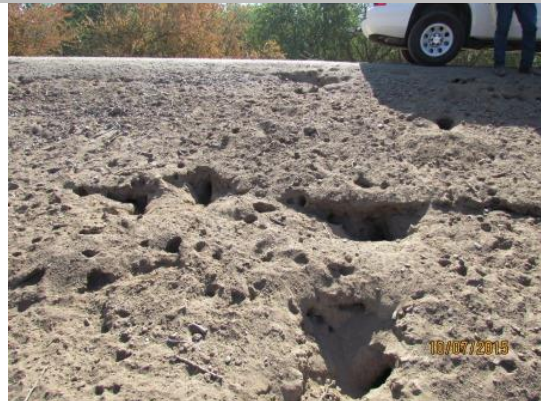
Photo 2 of 2 : FA\_2015\_RD2031\_307\_52\_20151008\_00056.jpg

Another view of the rodent holes on the waterside levee slope.

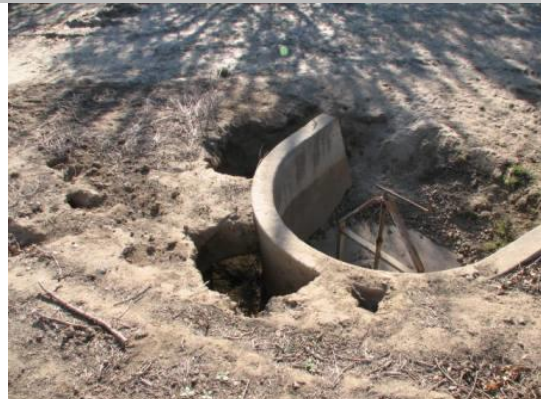
Photo 1 of 1 : FA\_2015\_RD2031\_307\_9\_20150910\_00011.jpg

LM Start	1.63	Rating **	U	Issue No.	9
LM End	1.63	Issue Type +	Ma	Location *	LS
Category	Earthen Levee			GPS Latitude/Longitude	
				Start	End
Item	Erosion / Bank Caving			37.698208 °	37.698208 °
				-121.175400 °	-121.175400 °
DWR ID	DWR_RD2031_01_s_2012_9				
Action/Comments					
Note and monitor erosion site. Inspector Comments: Active erosion around irrigation inlet in levee prism.

10/26/2011 Active erosion into levee prism around irrigation inlet.

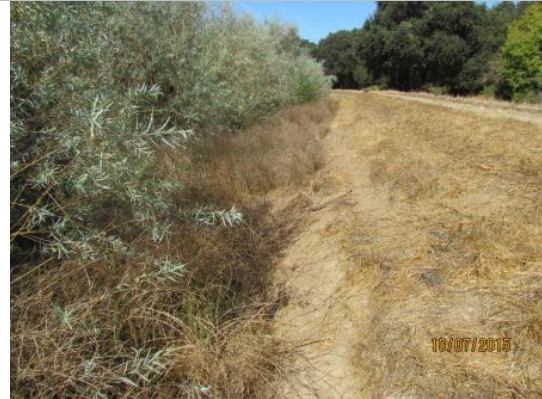
Photo 1 of 1 : FA\_2015\_RD2031\_307\_57\_20151008\_00057.jpg

LM Start	3.78	Rating **	M	Issue No.	57
LM End	3.81	Issue Type +	Ma	Location *	LS
Category	Earthen Levee			GPS Latitude/Longitude	
				Start	End
Item	Erosion / Bank Caving			37.690302 °	37.690664 °
				-121.200232 °	-121.200549 °
DWR ID	DWR_RD2031_01_f_2015_57				
Action/Comments					
Schedule repair of erosion site prior to the next inspection.					
Inspector Comments: Erosion at the landside levee toe.

View of the 18 inch vertical cut at the landside levee toe.

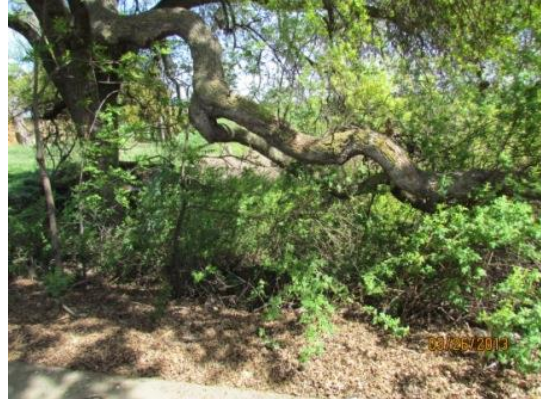
Photo 1 of 1 : FA\_2015\_RD2031\_308\_15\_20150910\_00007.jpg

LM Start	1.41	Rating **	M	Issue No.	15
LM End	1.41	Issue Type +	Ma	Location *	LS
Category	Earthen Levee			GPS Latitude/Longitude	
				Start	End
Item	Trim / Thin Trees			37.648080 °	37.648080 °
				-121.221031 °	-121.221031 °
DWR ID	DWR_RD2031_02_s_2013_15				
Action/Comments					
Trim trees to at least five feet above ground level.

View of the tree limb obstructing visibility and access to the landside levee slope.

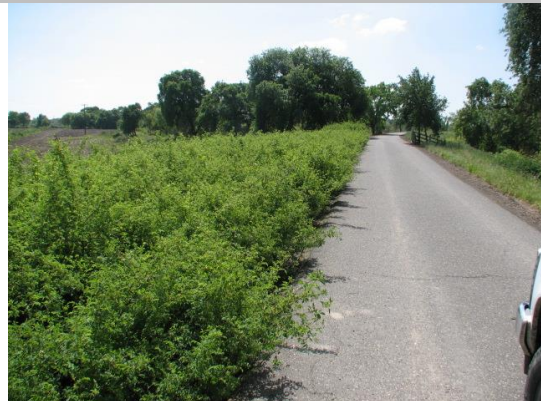
Photo 1 of 1 : FA\_2015\_RD2031\_308\_965\_20150910\_00013.jpg

LM Start	1.44	Rating **	U	Issue No.	965
LM End	1.46	Issue Type +	Ma	Location *	LS
Category	Earthen Levee			GPS Latitude/Longitude	
				Start	End
Item	Vegetation			37.647708 °	37.647462 °
				-121.220873 °	-121.220857 °
DWR ID	DWR_RD2031_02_s_2012_965				
Action/Comments					
Remove the wild growth other than native grasses from the levee slopes.					
Inspector Comments: Wild rose bush on landside slope.

Wild rose on levee slope.

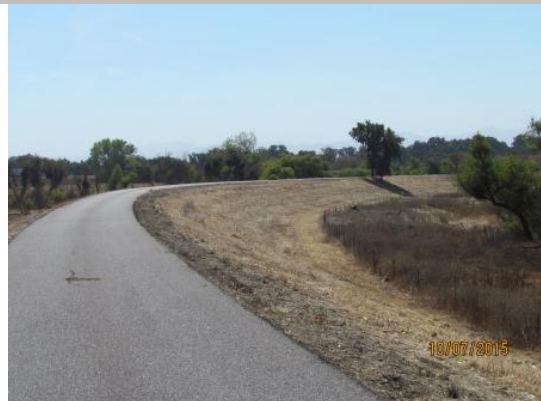
Photo 1 of 1 : FA\_2015\_RD2031\_308\_18\_20151008\_00021.jpg

LM Start	1.51	Rating **	A	Issue No.	18
LM End	1.51	Issue Type +	Ma	Location *	WS
Category	Earthen Levee			GPS Latitude/Longitude	
				Start	End
Item	Vegetation			37.646676 °	37.646676 °
				-121.220506 °	-121.220506 °
DWR ID	DWR_RD2031_02_f_2015_18				
Action/Comments					
Control annual grass and weeds on the levee slopes and easements.

View of the acceptable vegetation control.

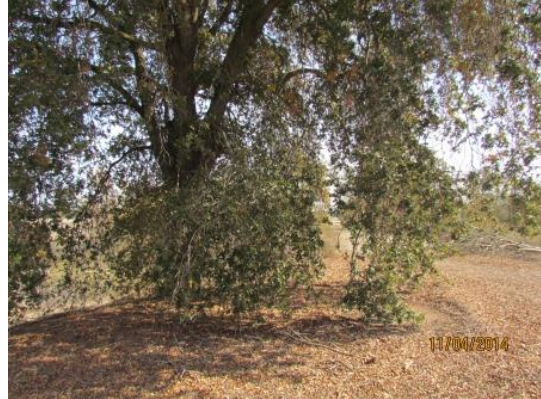
Photo 1 of 1 : FA\_2015\_RD2031\_308\_25\_20150910\_00011.jpg

LM Start	2.01	Rating **	M	Issue No.	25
LM End	2.01	Issue Type +	Ma	Location *	LS
Category	Earthen Levee			GPS Latitude/Longitude	
				Start	End
Item	Trim / Thin Trees			37.640874 °	37.640874 °
				-121.223870 °	-121.223870 °
DWR ID	DWR_RD2031_02_f _ 2014_25				
Action/Comments					
Trim trees to at least five feet above ground level.

View of the overgrown tree obstructing visibility and access of the landside levee slope.

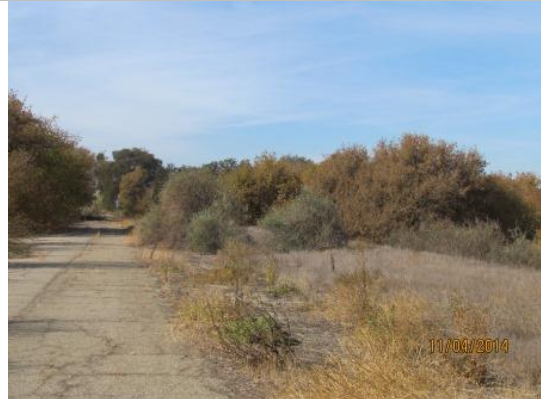
Photo 1 of 1 : FA\_2015\_RD2031\_308\_21\_20150910\_00009.jpg

LM Start	2.14	Rating **	M	Issue No.	21
LM End	2.14	Issue Type +	Ma	Location *	CR
Category	Earthen Levee			GPS Latitude/Longitude	
				Start	End
Item	Vegetation			37.640632 °	37.640632 °
				-121.221539 °	-121.221539 °
DWR ID	DWR_RD2031_02_f_2014_21				
Action/Comments					
Remove the wild growth other than native grasses from the levee slopes.

View of overgrown vegetation on the levee crown.

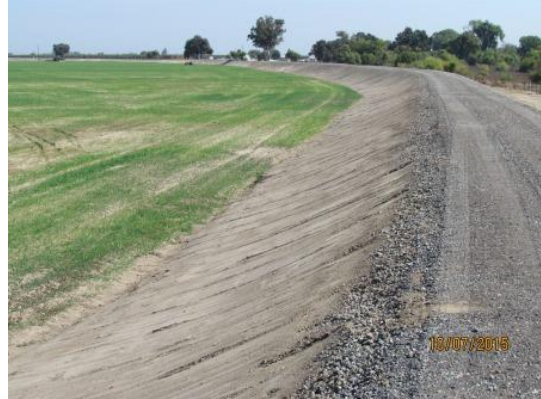
Photo 1 of 1 : FA\_2015\_RD2031\_308\_20\_20151008\_00022.jpg

LM Start	4.25	Rating **	A	Issue No.	20
LM End	4.25	Issue Type +	Ma	Location *	LS
Category	Earthen Levee			GPS Latitude/Longitude	
				Start	End
Item	Vegetation			37.632161 °	37.632161 °
				-121.190290 °	-121.190290 °
DWR ID	DWR_RD2031_02_f _ 2015_20				
Action/Comments					
Control annual grass and weeds on the levee slopes and easements.

View of the acceptable vegetation control on the landside levee slope.

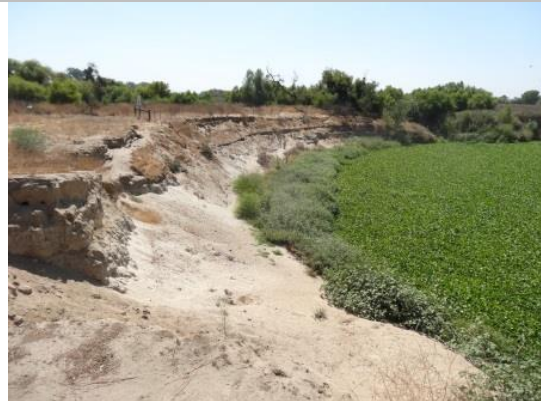
Photo 1 of 3 : SJR2015\_RD2031U02RM78.70\_1.jpg

LM Start	4.29	Rating **	A/W	Issue No.	1
LM End	4.33	Issue Type +	Ma	Location *	WS
Category	Supplemental			GPS Latitude/Longitude	
				Start	End
Item	DWR Erosion Survey			37.631716 °	37.631716 °
				-121.189370 °	-121.189370 °
DWR ID					
Action/Comments					
Inspector Comments: 08/19/2015: No significant change observed. 7/17/2014: The erosion has slightly expanded toward levee toe at two pocket locations. 09/10/2013: The site has been visited. The erosion has expanded toward levee crest at two pocket locations. 07/18/2012: No significant change observed on the site. 08/18/2011: No significant change observed on the site. Dead trees and animal activities are visible. The closest point of the erosion site to the levee toe is about 100 ft. 10/19/2010: There is active scouring occurring on the bank due to the nature of the flow and the lack of armor protection. There is also a fallen log immediately downstream of where the erosion has occurred and is protruding outward, possibly creating an eddy and scouring the bank. With the remaining 100-foot wide berm, the levee prism is not yet affected. However, the bank will continue to degrade, and eventually intrude into the levee prism if no protection is put in place. Erosion site is recommended for annual assessment and monitoring during flood events. [2015 Site ID:RD2031U02RM78.7]

Looking downstream.

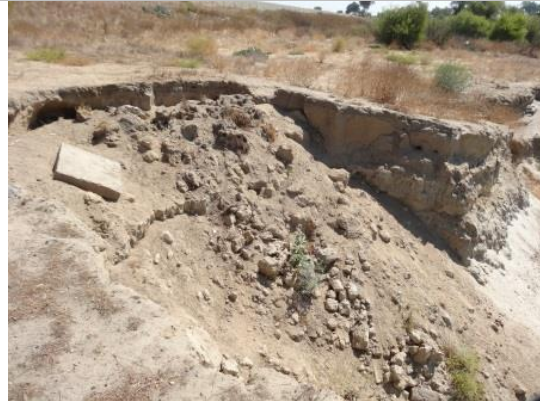
Photo 2 of 3 : SJR2015\_RD2031U02RM78.70\_2.jpg

Inspector Comments: 08/19/2015: No significant change observed.  
 7/17/2014: The erosion has slightly expanded toward levee toe at two pocket locations.  
 09/10/2013: The site has been visited. The erosion has expanded toward levee crest at two pocket locations.  
 07/18/2012: No significant change observed on the site.  
 08/18/2011: No significant change observed on the site. Dead trees and animal activities are visible. The closest point of the erosion site to the levee toe is about 100 ft.  
 10/19/2010: There is active scouring occurring on the bank due to the nature of the flow and the lack of armor protection. There is also a fallen log immediately downstream of where the erosion has occurred and is protruding outward, possibly creating an eddy and scouring the bank. With the remaining 100-foot wide berm, the levee prism is not yet affected. However, the bank will continue to degrade, and eventually intrude into the levee prism if no protection is put in place. Erosion site is recommended for annual assessment and monitoring during flood events. [2015 Site ID:RD2031U02RM78.7]

Close view of the pocket erosion.

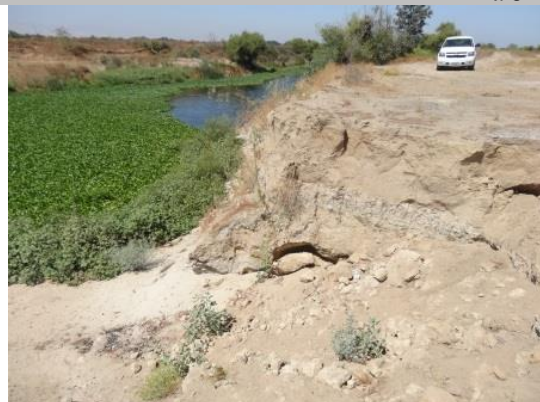
Photo 3 of 3 : SJR2015\_RD2031U02RM78.70\_8.jpg

Looking upstream. Note the pocket erosion.
